Bins 1&2 Roof Upgrade in Screen House

WEST ANGELAS, WESTERN AUSTRALIA

PROJECT OVERVIEW

CLIENT: Rio Tinto Iron Ore
ENVIRONMENT: Brownfield

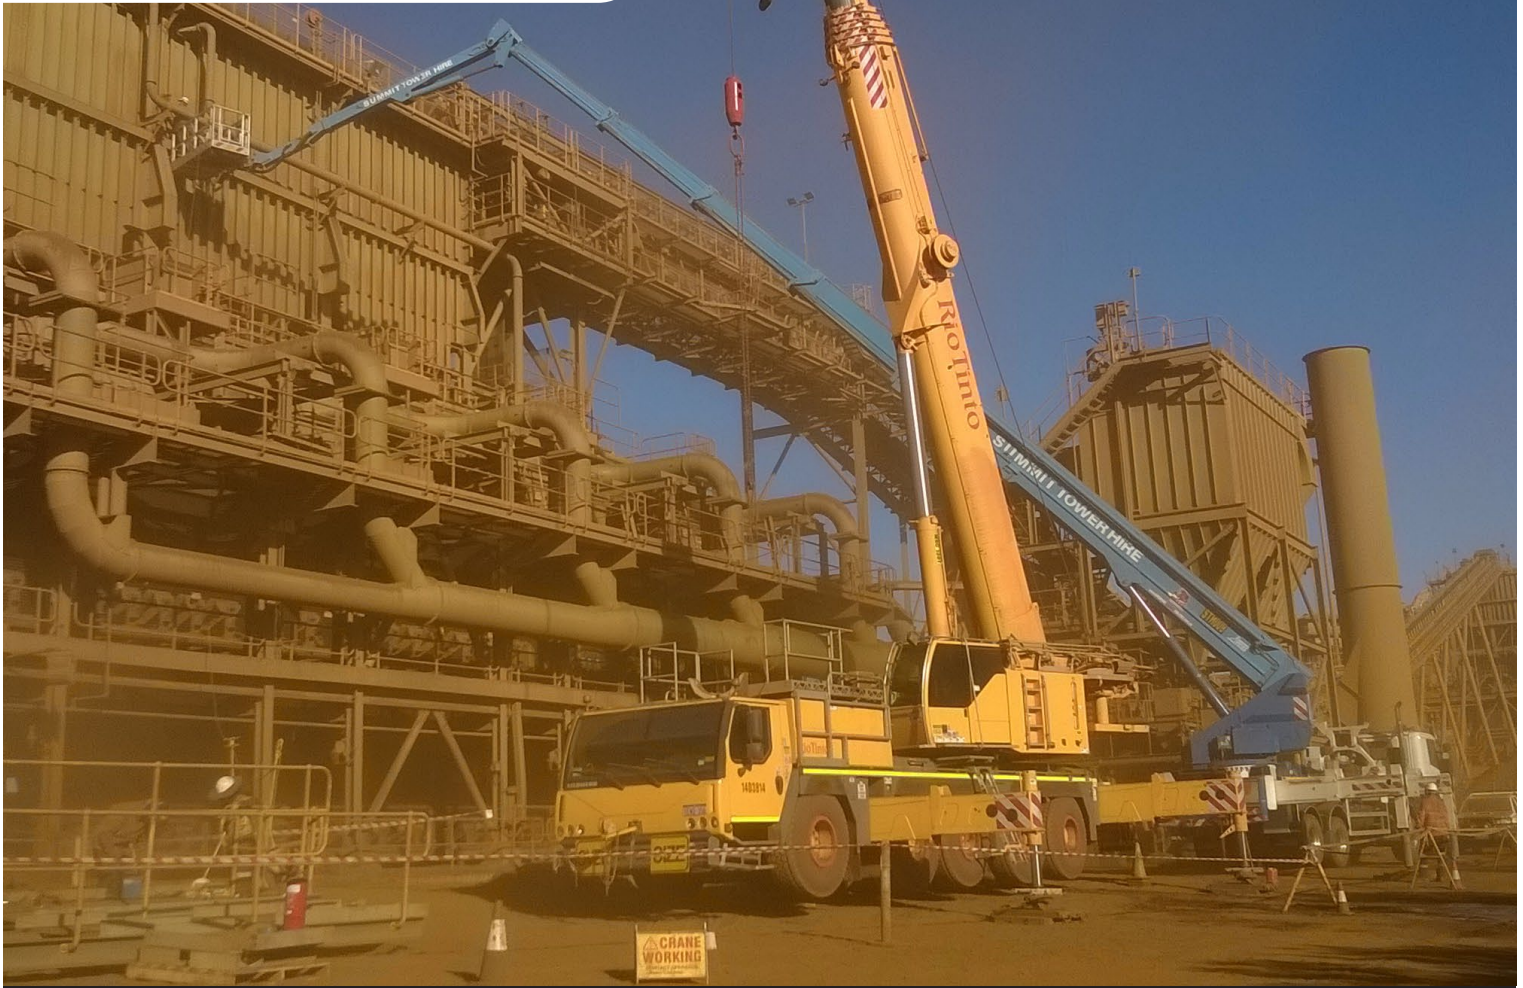
The screen house at West Angelas separates iron ore into lump and fines. Inspection of the steel work in the top of bins 1 and 2 had revealed the condition of the plant had degraded due to corrosion.

G&S completed repairs to restore structural integrity. Works were to be completed over a number of shutdowns on an ongoing basis and include structural repairs to beams on top of bin 1 and 2, compensation plate fabrication and installation, replacement of checker plate and galvanised floor grating, structural welding to Australian standards and application of protective coatings.
