Bins 1&2 Roof Upgrade in Screen House

WEST ANGELAS, WESTERN AUSTRALIA

PROJECT OVERVIEW

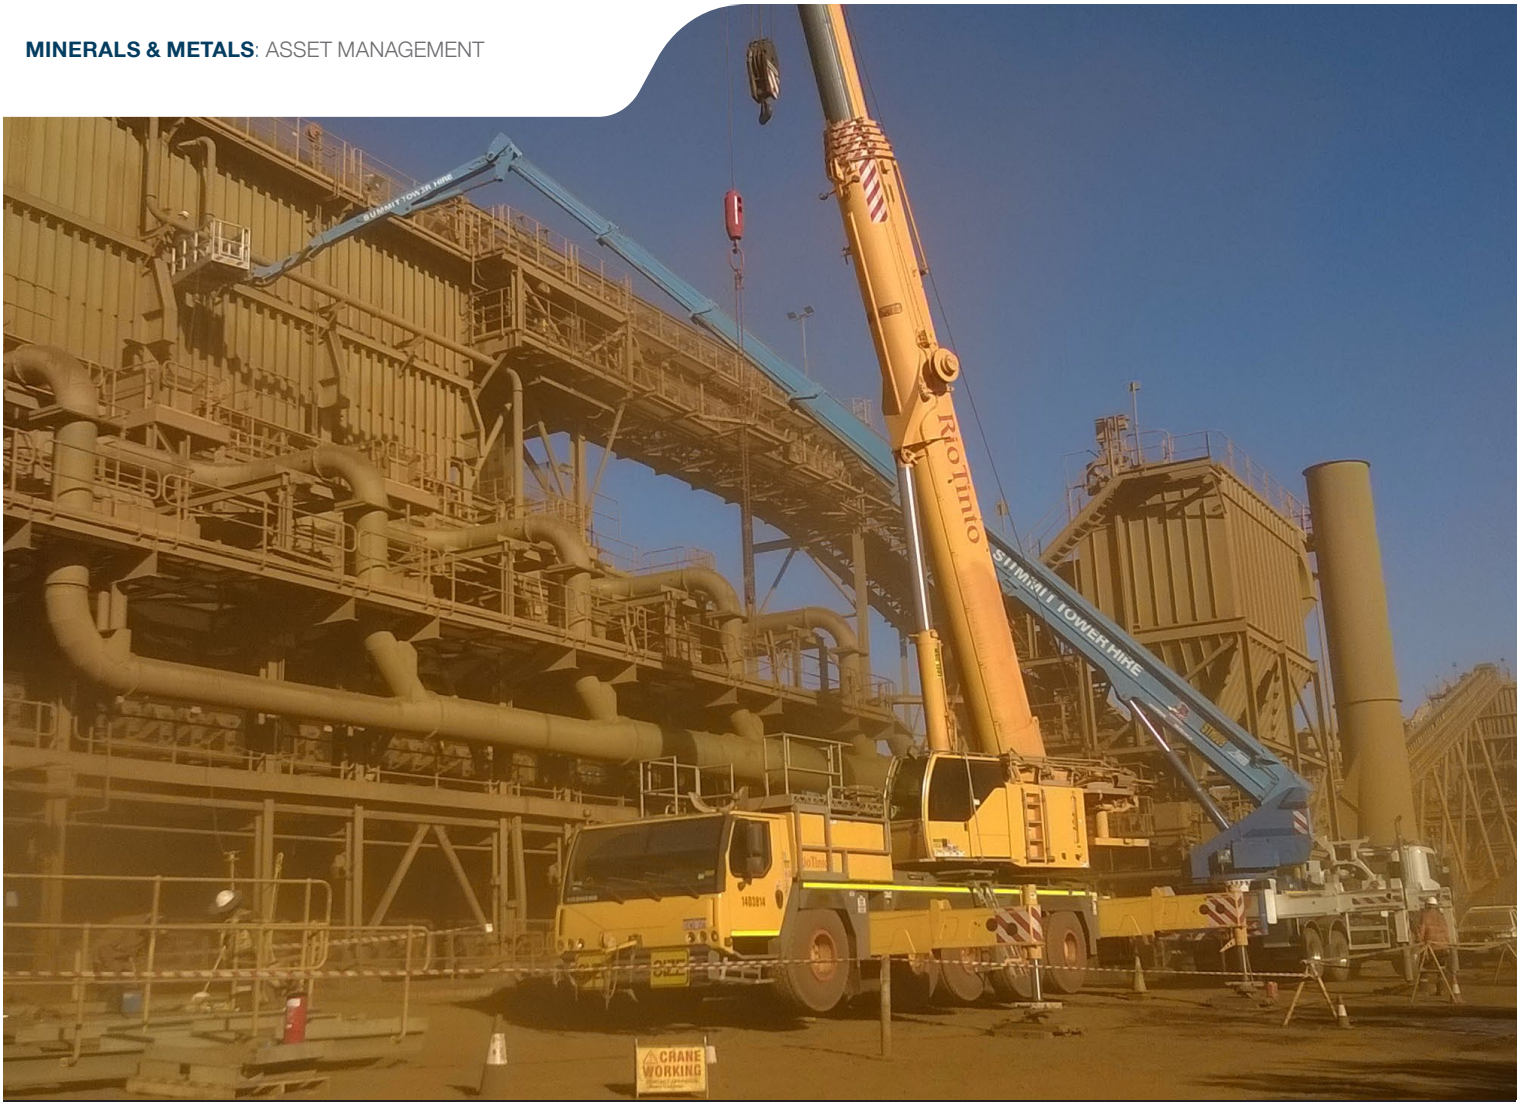
The screen house at West Angelas separates iron ore into lump and fines. Inspection of the steel work in the top of bins 1 and 2 had revealed the condition of the plant had degraded due to corrosion.

G&S completed repairs to restore structural integrity. Works were to be completed over a number of shutdowns on an ongoing basis and include structural repairs to beams on top of bin 1 and 2, compensation plate fabrication and installation, replacement of checker plate and galvanised floor grating, structural welding to Australian standards and application of protective coatings.
